CASE STUDY – PAUL & DONNA HINTON'S FARM 07-06-2010

Dairy race stabilisation with JakMatGeocell

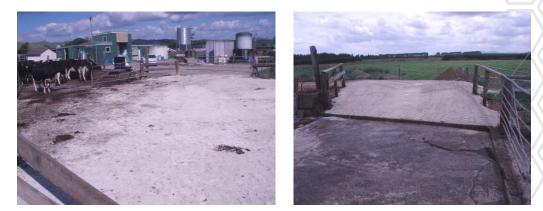
The total 200 square metres of JakMatGeocell was laid by Paul, Donna and daughter, three farm employees and toddler. The cells were then filled with the crushed lime and roll compacted with the rubber wheels tractor (right hand photo). A further 20 -50mm of crushed line was spread over the surface and also compacted.

4. The complete laying process took a total of 5 hours and the herd walked across the completed surface at 3.30pm on that day.

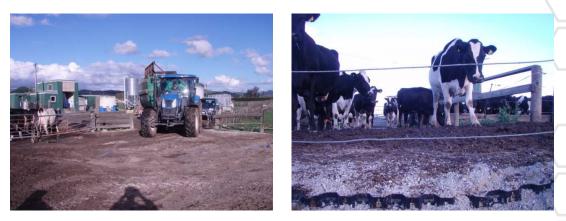
The **JakMatGeocell** has now been down on Paul and Donna Hinton's race for a little over 4 months and the following the observations were made by Paul Hinton.

- "I have not had a lame cow in the 4 months since the JakMat has gone down I would normally had 3 or 4 over that time.
- "We have just had two days of heavy rain and the whole area is standing up a lot better than it use too".
- "At this stage we are very happy"
