## CASE STUDY - DOC BULLER KAWATIRI AREA (24-08-2011)

**PROJECT:** Heaphy Track Upgrade (completed in August 2011)

### Track Description & Project Brief

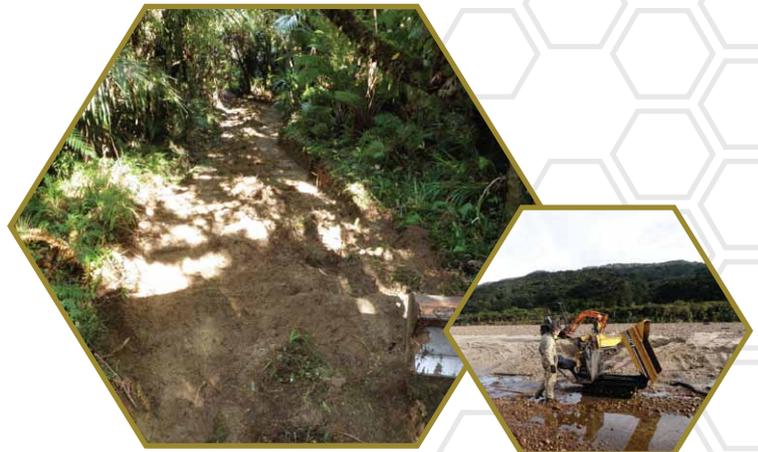
3. The *JakMatEnviro* was laid, long side across (585mm) in a continuous strip up the middle of the prepared track.

4. The mats were pegged using 10mm deformed steel rods. Six meter lengths of this rod were cut into 300mm length and a 50mm right angle return put on one end. The pegs were driven into the sub base through the holes on one side of the mats cell. With the 50mm return, on top of the peg, this enabled it to span across the base of the cell and very securely attach the mat to the ground. This pegging will eliminate the potential for the mat to pump (move up and down with people and bike traffic) which can lead to, soft and water sodden base aggregate to move up through the mat and cause premature deterioration of the track surface. The total number of pegs used for the 2 kilometre upgrade was 720.

5. The filling of the *JakMatEnviro* mat with the aggregate and forming of the crown topping layer. The crowning layer ranged in depth from 150mm thick in the middle of the mat tapering down at the sides of the prepared track.
